# Nahant Public Library Master Plan 2025 Update

15 Pleasant Street  
Nahant, MA 01908

**Nahant Public Library**  
**Updated Master Plan Study**  
**Table of Contents**

31 March 2025

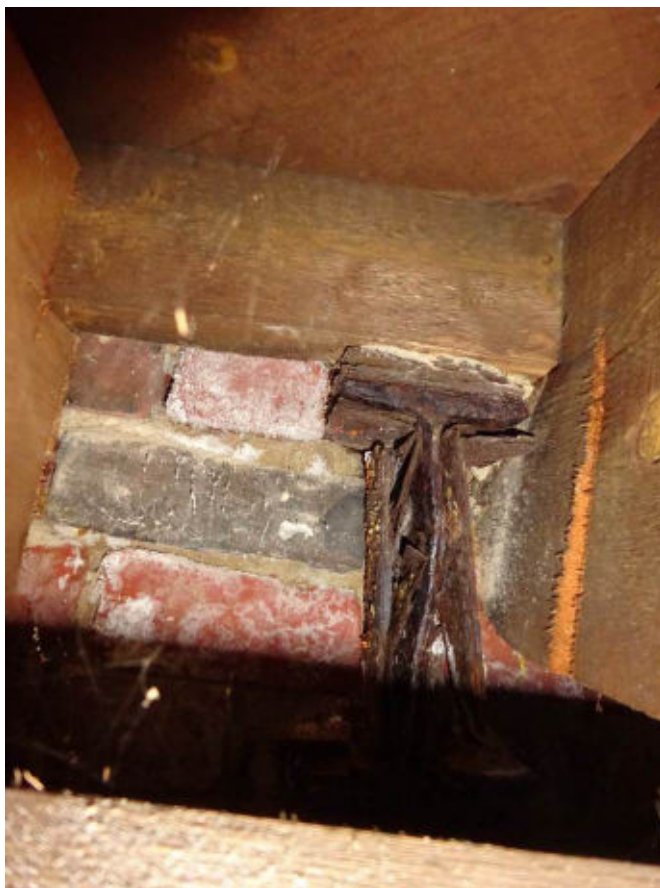
**Photo #1**

Corroded steel beam end at interior/west edge of reading room

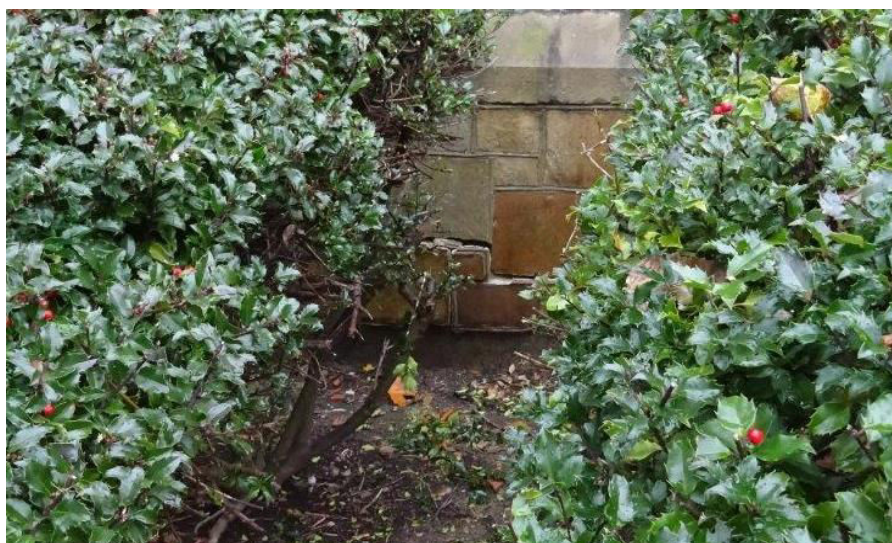
**Photo #2**

Damaged masonry at exterior, likely due to rust-jacking beam end

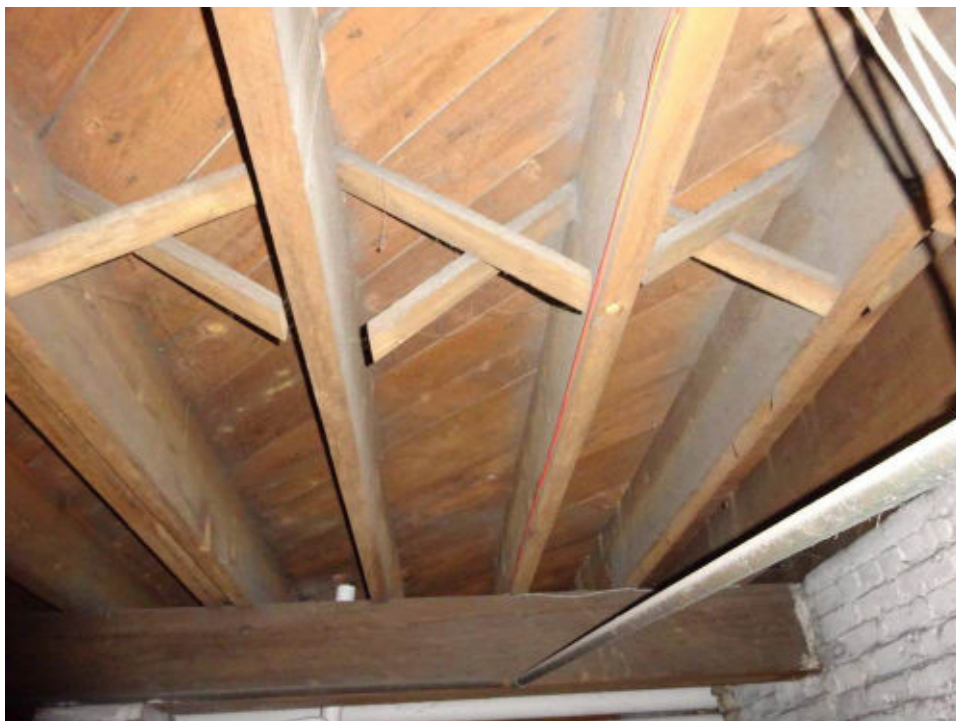
**Photo #3**

Photo #3: Bridging missing nailing and lack of bridging at bearing line

Bridging missing nailing and lack of bridging at bearing line

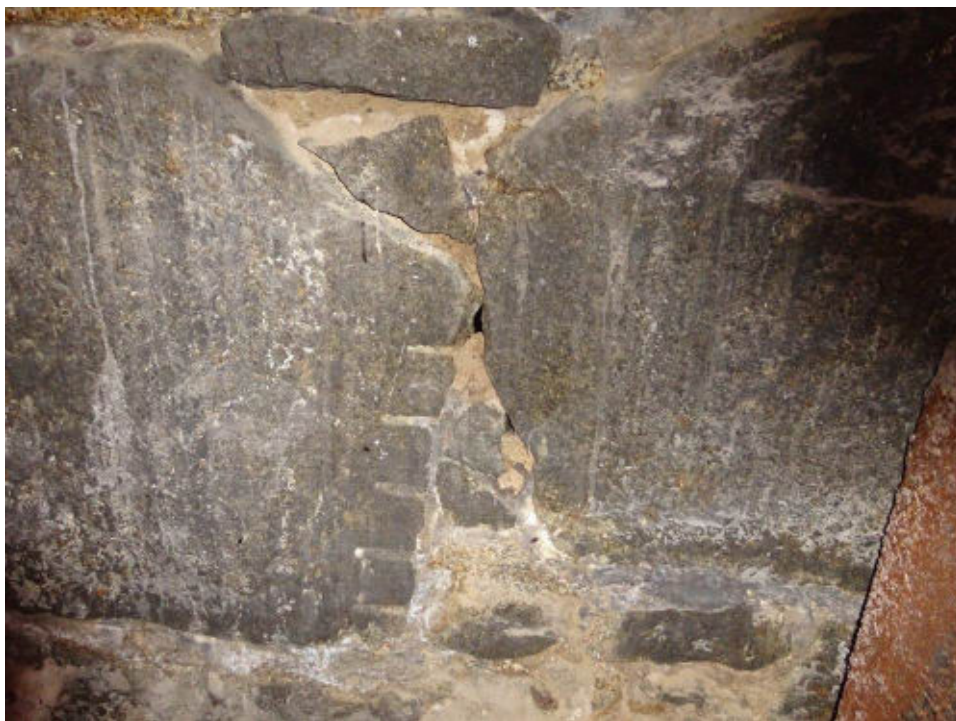
**Photo #4**

Photo #4: Deteriorated joints in masonry foundation wall

Deteriorated joints in masonry foundation wall

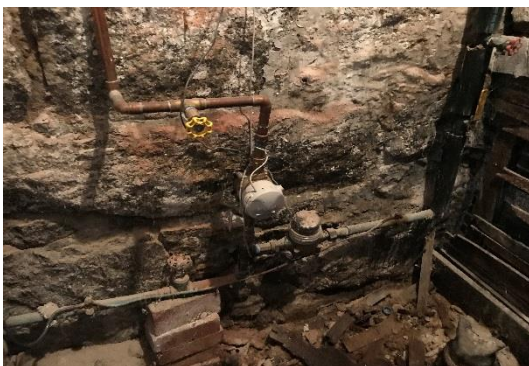
*Water Meter*

Domestic water enters the building in (1) location. A 1" service and associated meter is provided. Piping is a combination of steel and copper piping. The piping was noted to be in fair to poor condition.

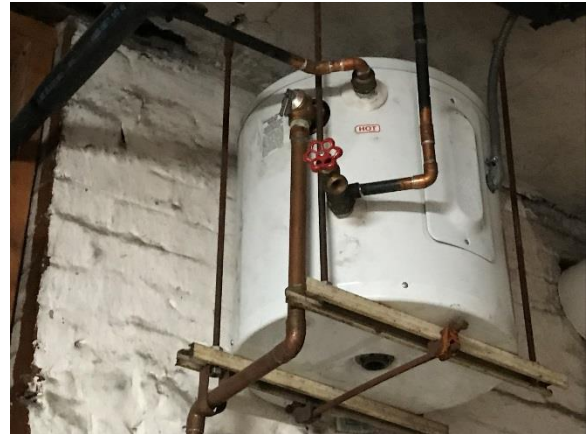
*Hot Water Heater*

Domestic hot water was produced via (2) 10 gal electric tank type hot water heaters installed in the ceiling of the basement. The tanks were showing signs of age and appear to be outside of their warrantee period.

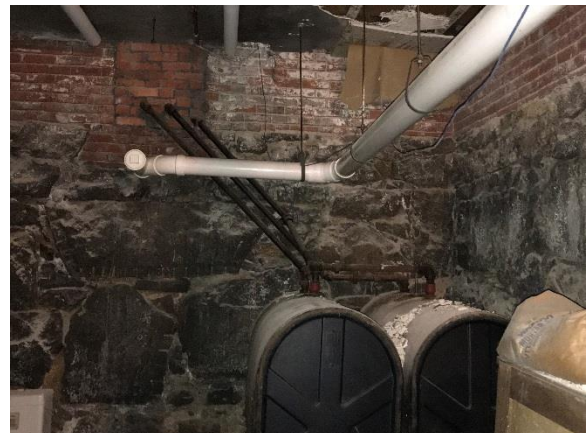
*Sanitary Piping*

Sanitary piping is a mixture of cast iron, copper and PVC. It is noted that PVC should not be used in this commercial application per 248 CMR. The remainder of piping was in fair to poor condition.

- *Plumbing:* The existing piping is at the end of its service life, and the plastic waste piping in the basement is not allowed in non-residential occupancies. Additionally, the fixture count does not meet current codes and needs to be augmented. Any substantial renovation should incorporate the complete replacement of the plumbing system.

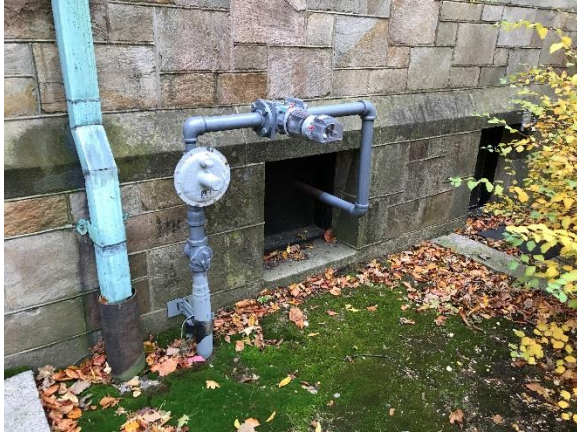
*Gas Meter*

Natural gas appears to be the current fuel source. A single gas meter is provided and a 2" main serves the existing steam boilers. The gas piping appeared to be in good condition.

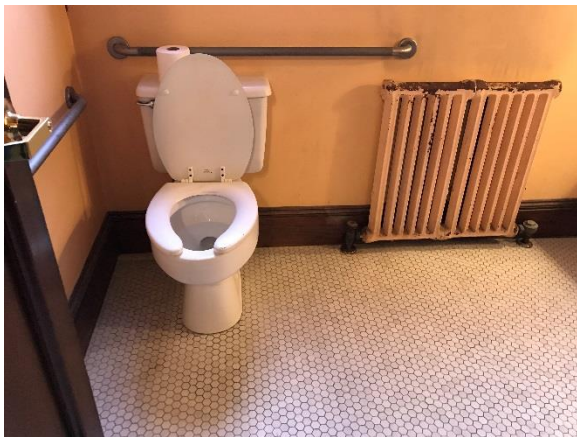
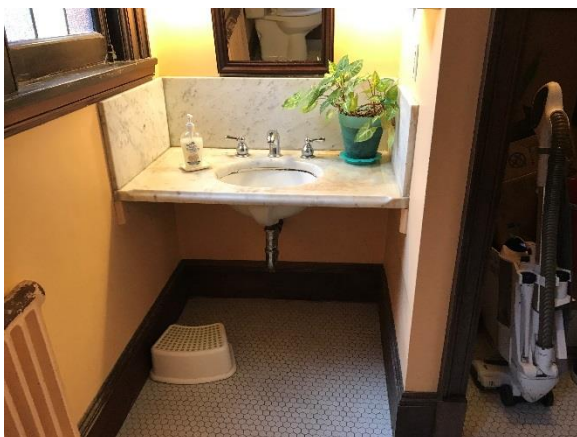
*Typical Plumbing Fixtures*

Plumbing fixtures were standard grade tank type toilets and counter mounted vanities. Fixtures appeared close to the end of their useful life and are not ADA compliant.

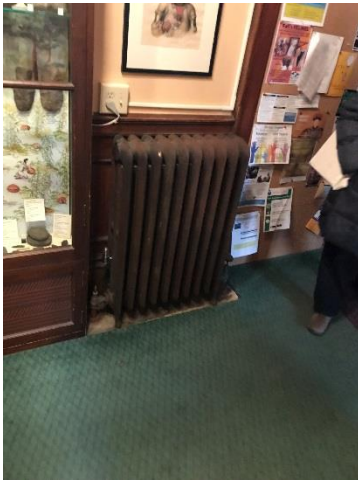
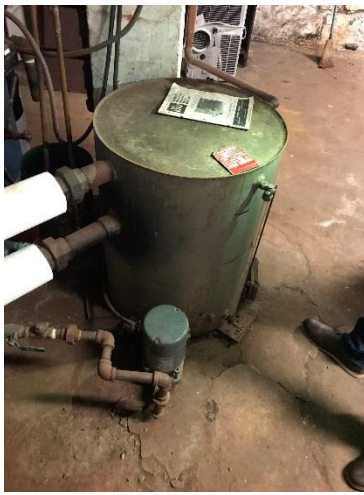
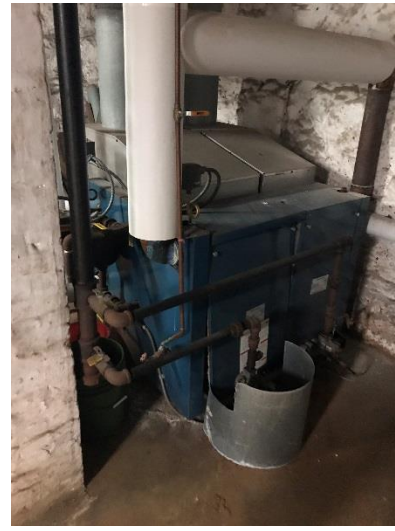
The building is heated with a natural gas boiler located in the basement. Steam is distributed throughout the building with a steam supply and condensate return piping system. Spaces are heated by steam radiators. Ventilation is through ductwork and floor grille.

- *HVAC system:* the present heating system is inefficient and does not address ventilation or summer cooling. The engineers have recommended a variable refrigerant system for heating and cooling throughout the building. Such a system could be modular, with an initial phase that installs a new system in the existing building in the near term and adds systems for any addition as part of that construction.

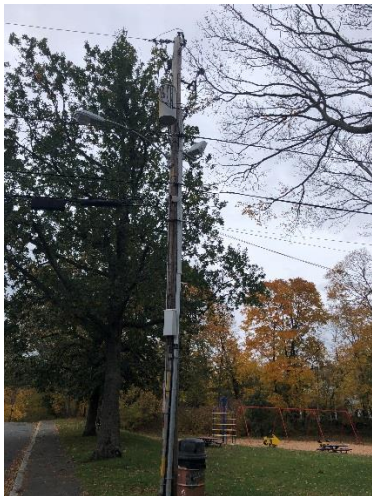
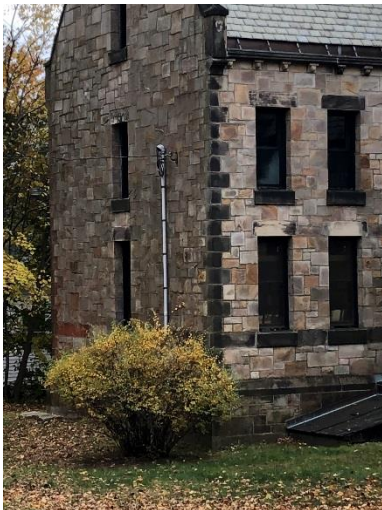
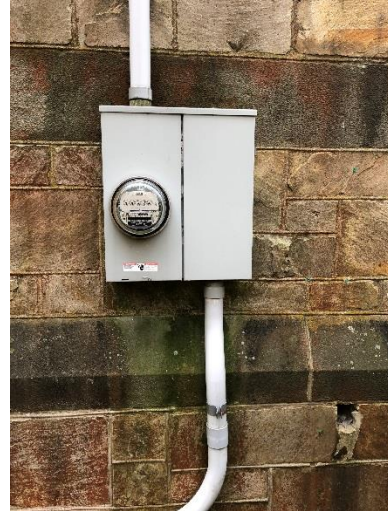
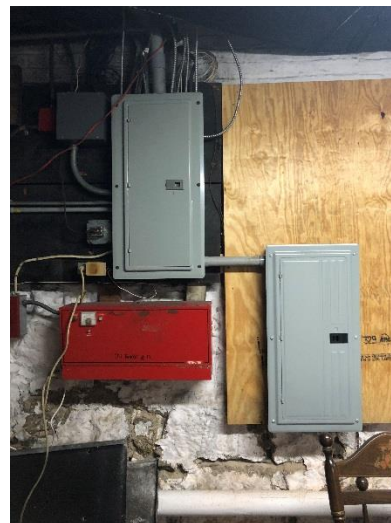
The main service originates from a 240 volt, 1-phase utility pole mounted transformer on Pleasant Street, runs overhead to another utility pole located at the rear of the property, continues overhead to a weatherhead attached to the back of the building and terminates at an exterior Utility Meter. The service enters the basement through a 2" conduit and terminates in a loadcenter. The service size is unmarked, but believed to be a 200 amp, 120/240 volt, 1-phase, 3-wire service.

The main panelboard is a Murray 200 amp 120/240 volt, 1-phase, 3-wire, 30-circuit load center with no spares or spaces available. There is a second load center located directly to the right of the main panel which contains (24) spaces. Both panels appear to be in good condition and are approximately 5-10 years old.

The service entrance feeders and main service equipment are not of sufficient size to provide adequate power to a building of this size and type and the distribution is outdated and has no spare capacity. A new 800 amp, 120/208 volt, 3-phase, 4-wire service shall be provided in the

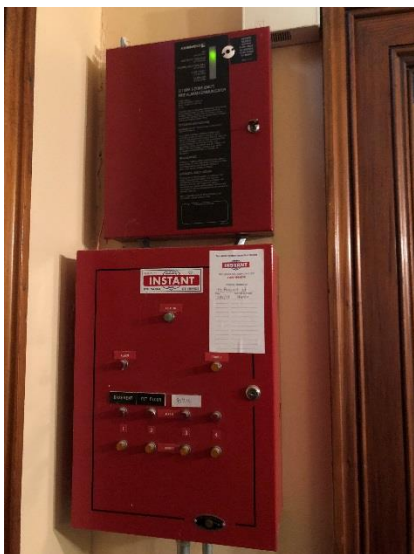
The building has an existing conventional 4-zone fire alarm control panel located at the entrance off Pleasant Street. The FACP is of an obsolete vintage and is past its expected life. The fire alarm system is connected to the Nahant fire department via a fire alarm communicator.

It is recommended that the entire system be replaced with a new addressable Fire Alarm system to meet the requirements of UL, Nahant Fire Department Bylaws, NFPA, Massachusetts State Building Code, 2015 International Building Code, ADA and 2015 International Fire Code.

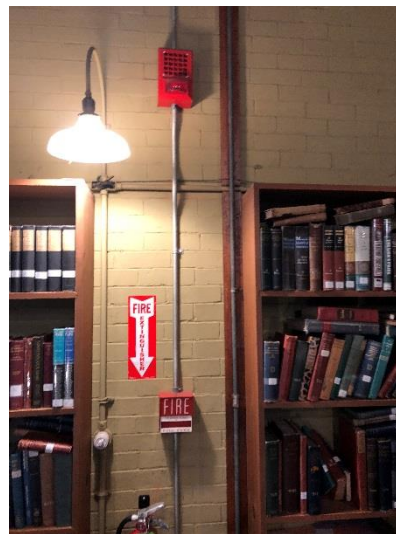
There are manual pull stations located within 5'-0" of existing doors in accordance with NFPA 72, however, many of the pull stations are at the incorrect ADA-required height. There are horn/strobe devices located sporadically throughout the building, but the notification coverage appears inadequate and does not meet current code requirements. The system also contains smoke and heat detectors throughout the facility.

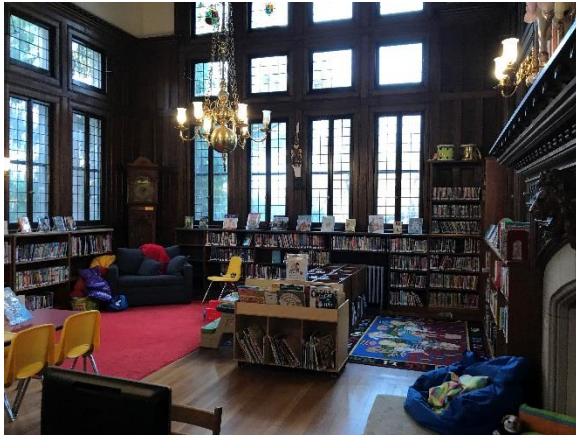
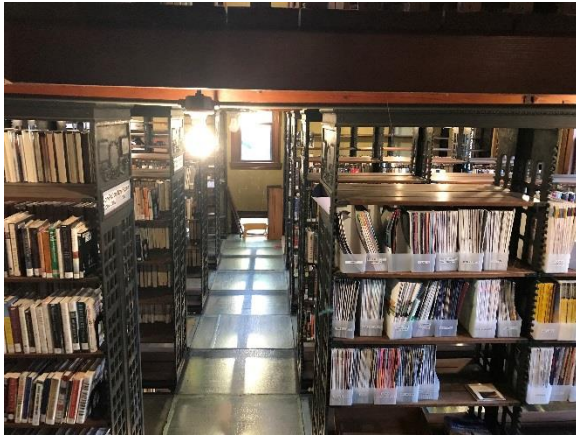
There is a multitude of existing fixture types throughout the building which all appear to be inefficient and have surpassed their expected useful life. Fixture types include; decorative pendants, jelly jar type fixtures in the stack area and decorative wall sconces. All fixtures appear

to contain incandescent lamping or have been replaced with LED replacement bulbs.

The fixtures have exceeded their expected usefulness and should all be replaced with new energy efficient LED-source light fixtures.
