Nahant Thicket Wildlife Sanctuary Ecological Restoration and Maintenance Plan

Mass Audubon's Ecological Extension Service

September 2017

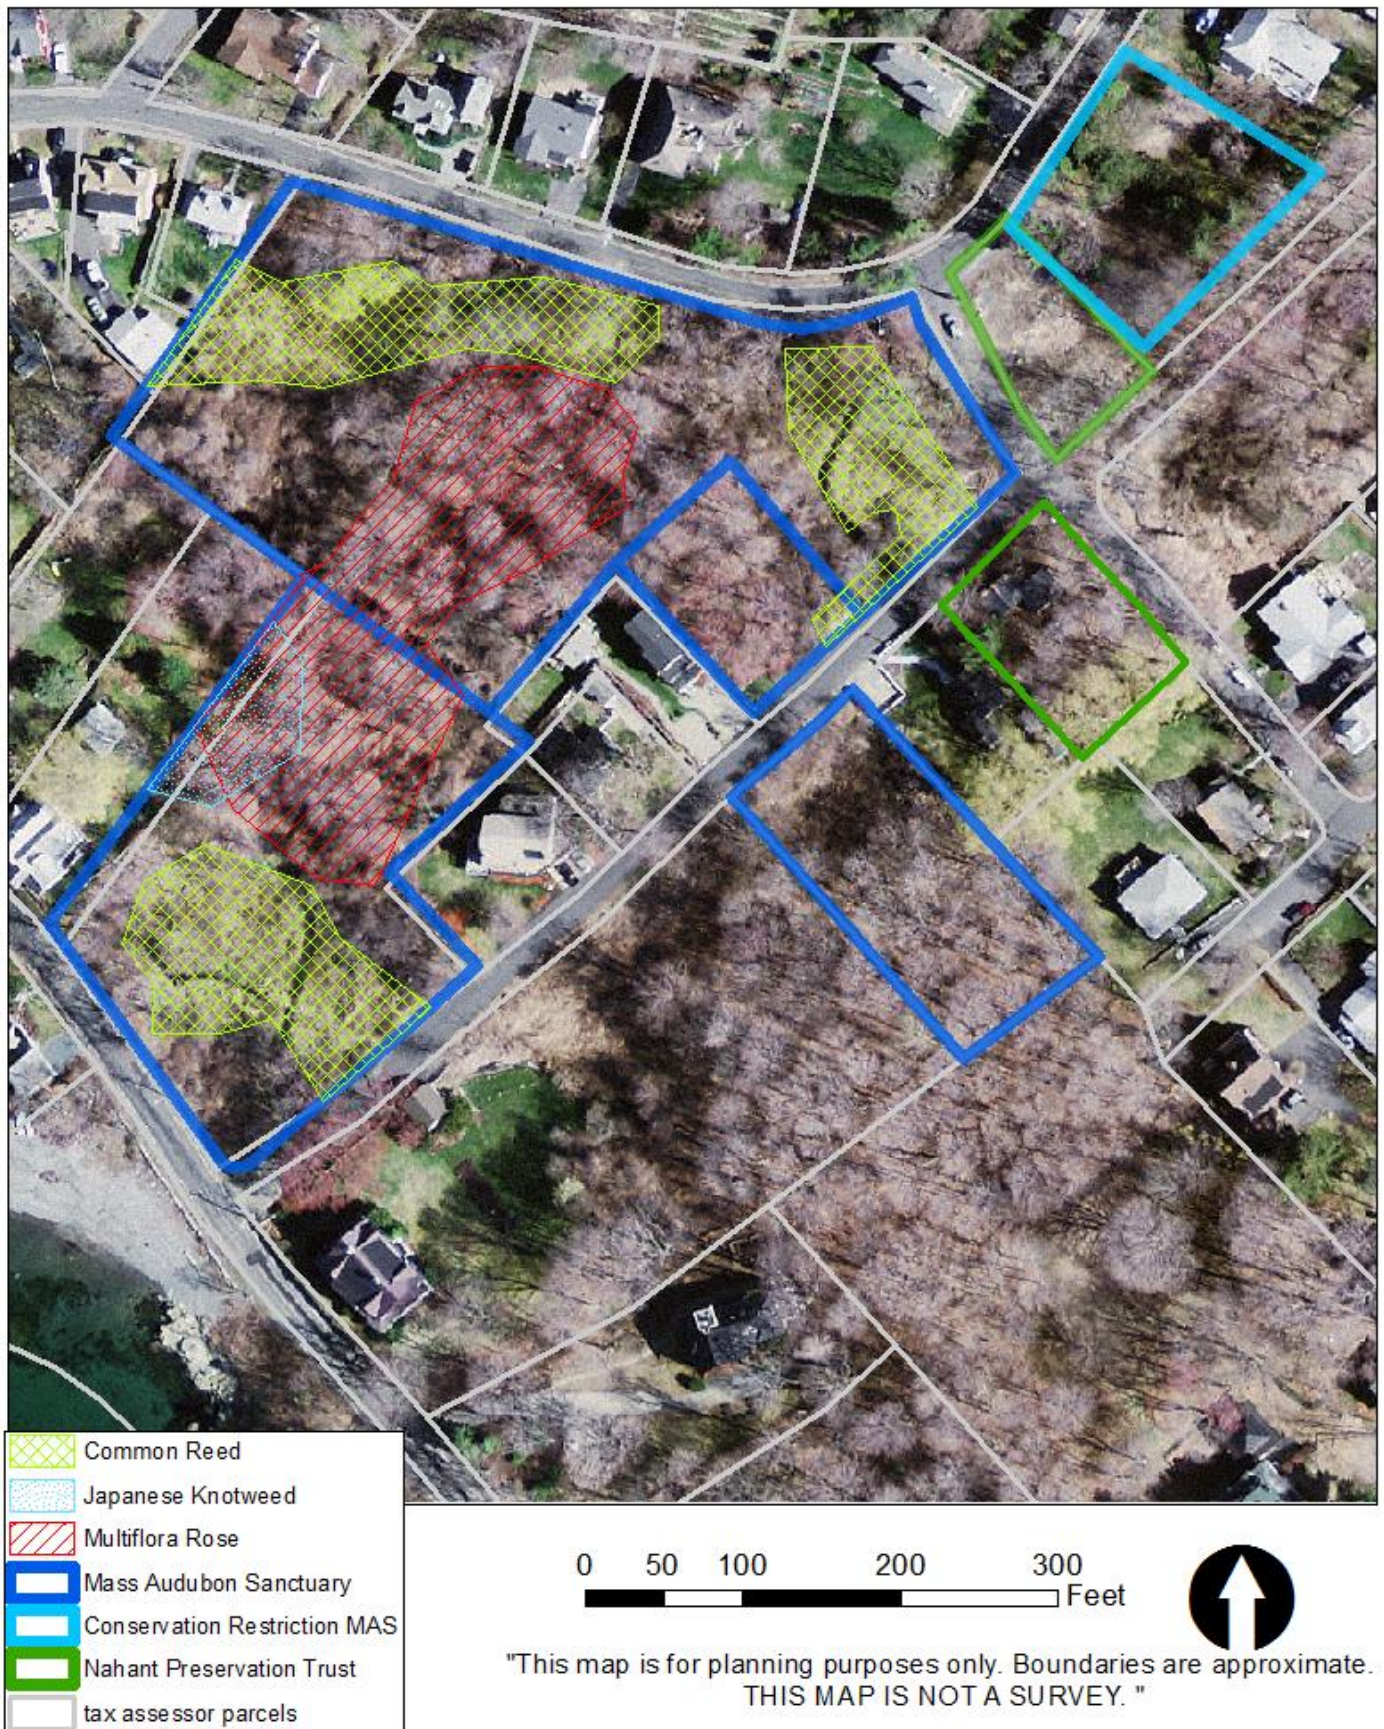
Figure 3: Distribution of the most common invasive plants at Nahant Thicket.

Invasive plant species are common and widespread on the sanctuary (Figure 3). The most common invasive species are common reed (*Phragmites australis ssp. australis*), multiflora rose (*Rosa multiflora*), oriental bittersweet (*Celastrus orbiculatus*), and Japanese knotweed (*Polygonum cuspidatum*). Other invasive plant species present are Norway maple (*Acer platanoides*), sycamore maple (*Acer pseudoplatanus*), garlic mustard (*Alliaria petiolata*), dame's rocket (*Hesperis matronalis*), Morrow's honeysuckle (*Lonicera morrowii*), winged euonymus (*Euonymus alatus*), purple loosestrife (*Lythrum salicaria*), border privet (*Ligustrum obtusifolium*), and common buckthorn (*Rhamnus cathartica*).

Common buckthorn	Scattered individuals along the streets that bound the sanctuary.
Multiflora rose	Dense thickets in many areas, especially along the trail in the interior of the sanctuary (Figure 3).
Common reed	Several stands occupy approximately one acre (25%) of the sanctuary (see Figure 3).

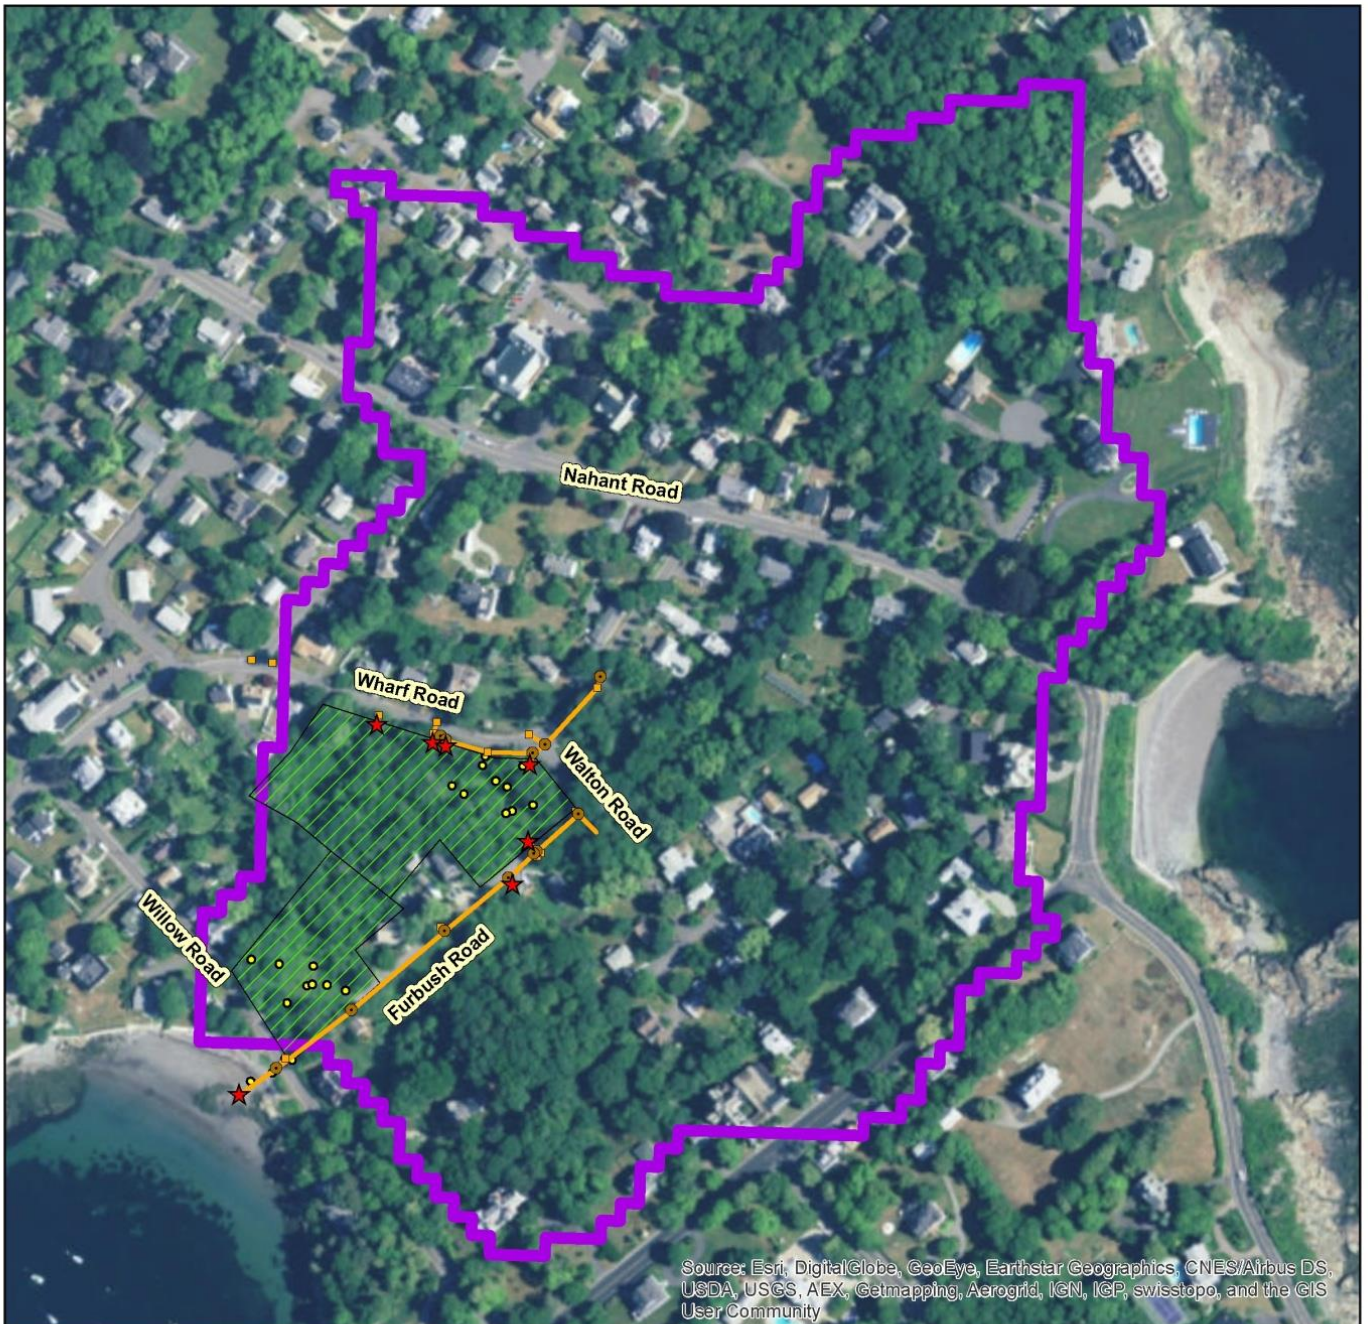
Figure 4: Extent of surrounding drainage into Nahant Thicket. Taken from Inter-Fluve hydrology report.

The property is located in a shallow valley surrounded by higher land to the north, west, and east, spilling out to the ocean to the south. As a result, the sanctuary receives storm water runoff and groundwater drainage from the surrounding residential neighborhood (Figure 4). The property is currently drained by a system of ditches and culverts ultimately draining to a stormwater pipe underneath Furbush Road which drains to the beach south of Willow Road (Figure 5).

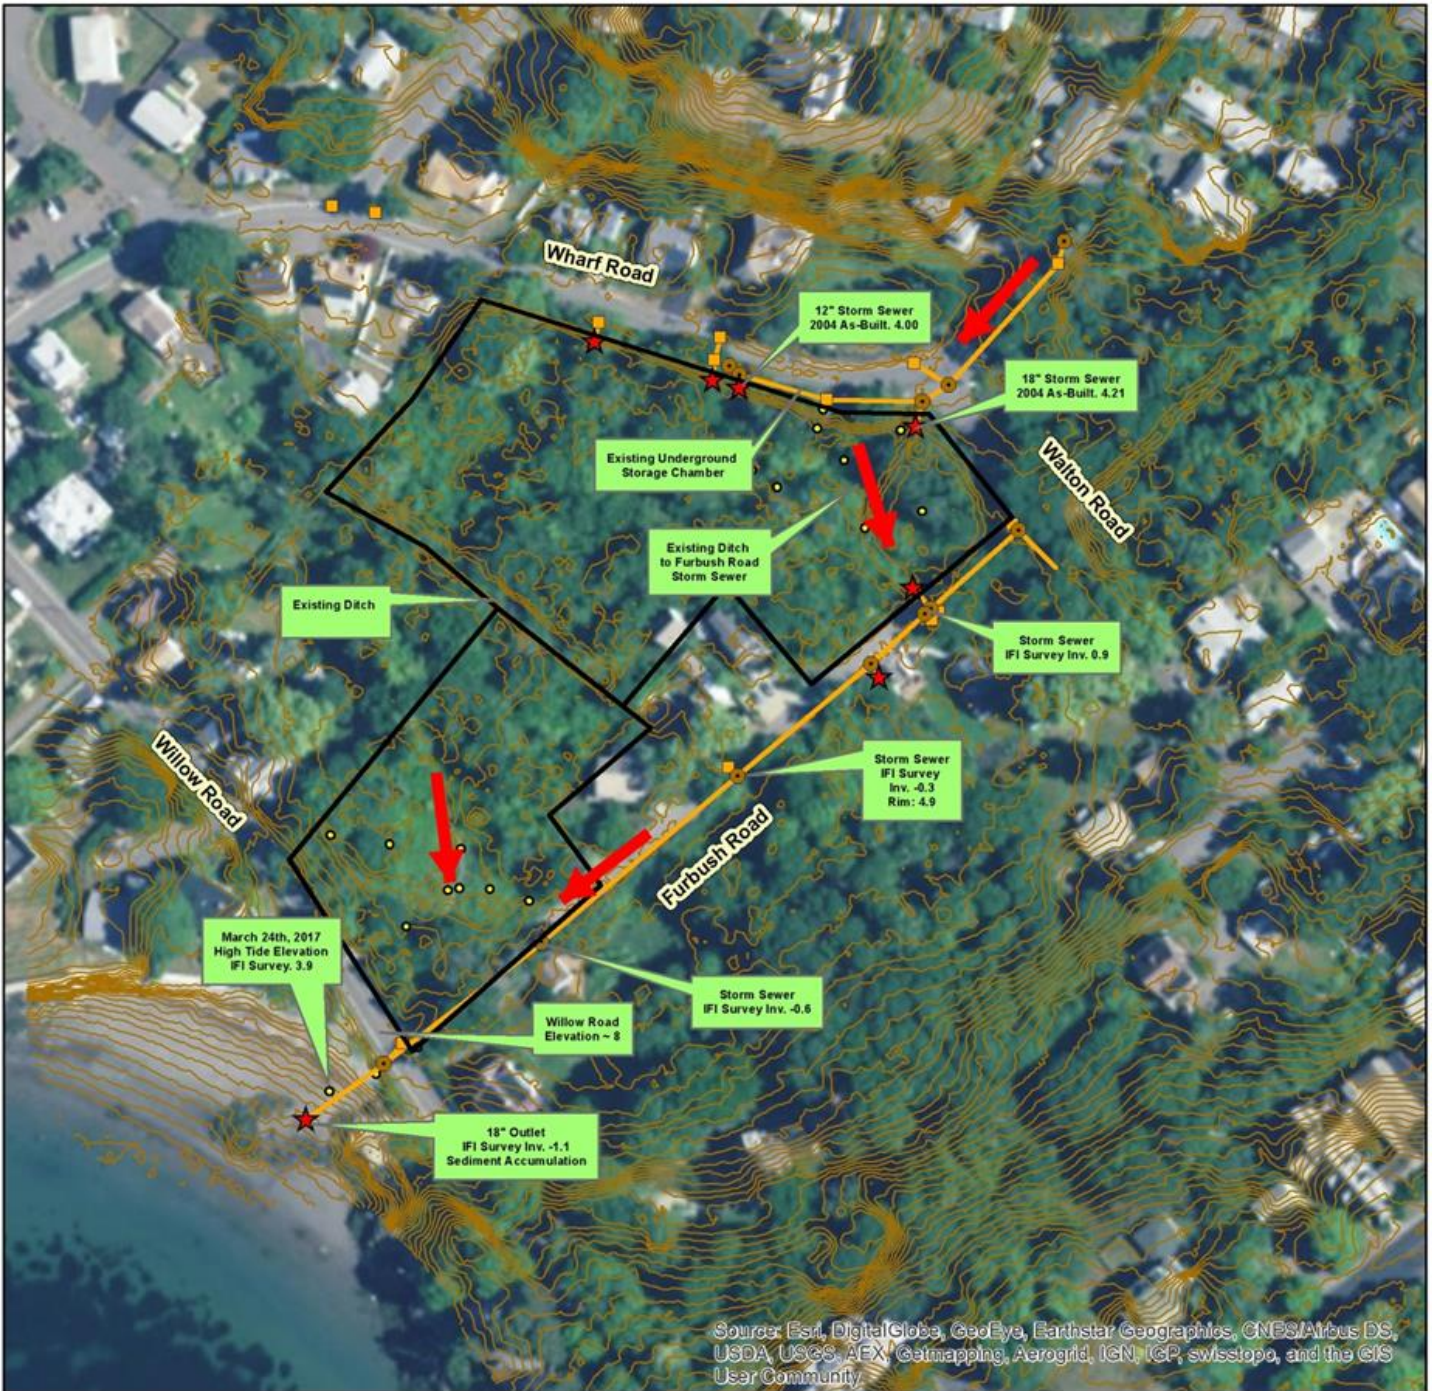
Figure 5: System of ditches and culverts for drainage at Nahant Thicket. Taken from Inter-Fluve Hydrology report.

Channel 1 -- A small ditch, approximately 8 feet wide and 1-2 feet deep located at the northeastern corner of the thicket. This channel receives stormwater outfall from Wharf Street and Walton Road, and drains southwest for approximately 80 feet and then southeast for another 80 feet before entering a pipe under Furbush Road. This pipe presumably connects with the main stormwater line under Furbush Road.

Channel 2 -- A widened ditch running west to east through the center of the Thicket. This channel drains water from the western part of the property, flowing northwest to southeast before entering an underground pipe on the west side of the abutting property at 18 Furbush Road. We presume that the underground pipe connects the stormwater pipe under Furbush Road. Although this channel has been maintained in the past for mosquito control, it is fairly vegetated now and retains puddled water. A grate at the downstream end of the channel becomes tends to become clogged with debris which also backs up water into the ditch.

Channel 3 -- At the southwestern end of the site, water drains through narrow swales less than one foot in depth before entering a pipe that we believe connects with the main stormwater system under Furbush Road. Field observations indicated that the pipe leading to Furbush Road is broken and may need repairs.

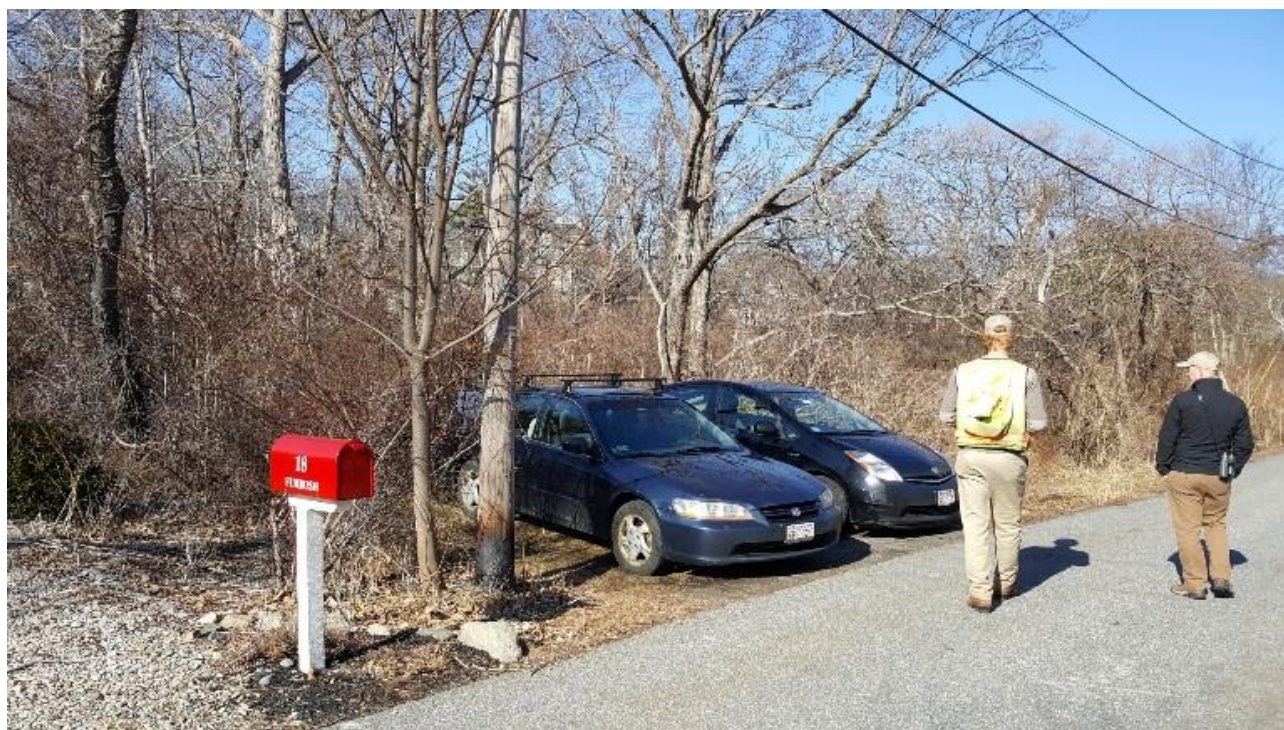
Figure 6: Parking on the North side of Furbush Road

Parking currently consists of two narrow, unsurfaced spaces directly abutting Furbush Road, adjacent to #18 Furbush Road (Figure 6). These spaces are relatively shallow and will comfortably accommodate only smaller vehicles. A small Mass Audubon parking sign indicates the parking spots. There is no trailhead at the parking area; visitors must walk either south along Furbush Road to the southern trail outlet or north on Furbush to Walton and Wharf to the northerly trail.

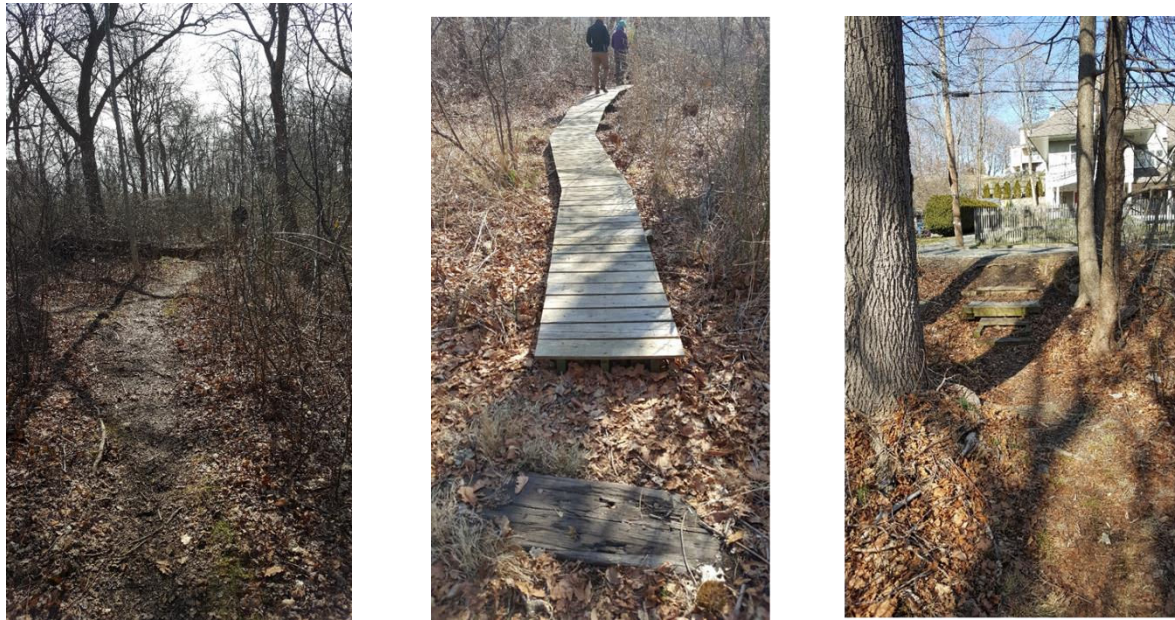
Figure 7: Existing trail conditions for the main trail.

A relatively narrow trail consisting of dirt surface and sections of boardwalk stretches approximately 1,000 feet from the southeast corner of the property on Furbush Road to the northern side of the property on Wharf Street (Figure 7). The trail includes roughly 200 feet of wooden boardwalks and a wooden bridge across the largest drainage ditch on the property (Figure 8). The trail includes three wooden steps up to Wharf Street and the boardwalks and the bridge require stepping up from and down to the dirt trail segments. The bridge is not of the most stable design and gaps at either end require a mindful step when going from the bank to the bridge.

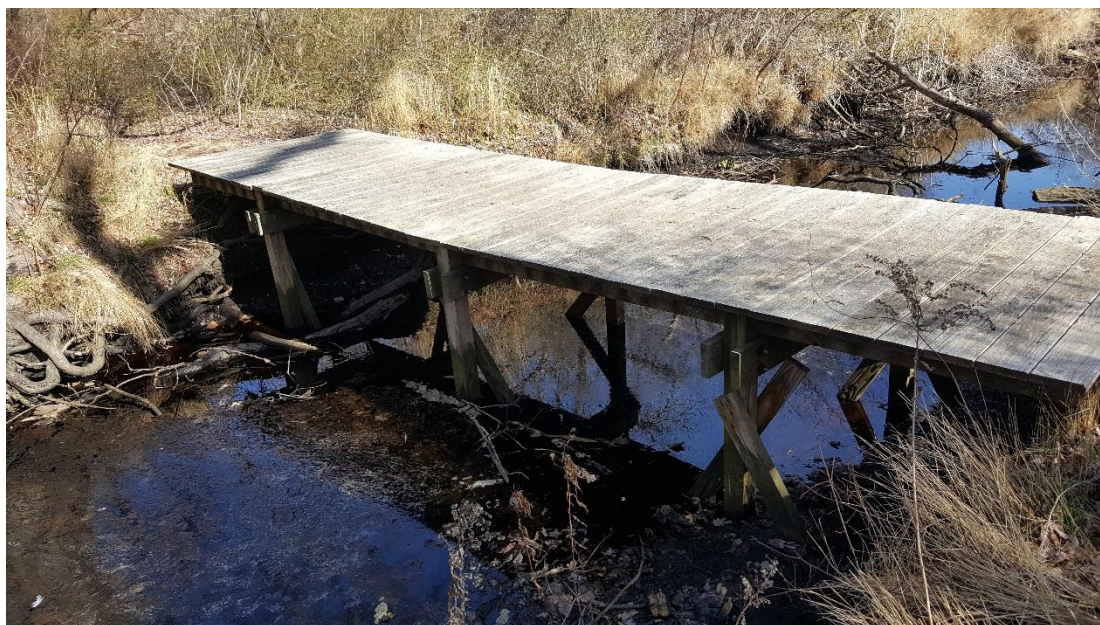
Figure 8: Bridge over central ditch.

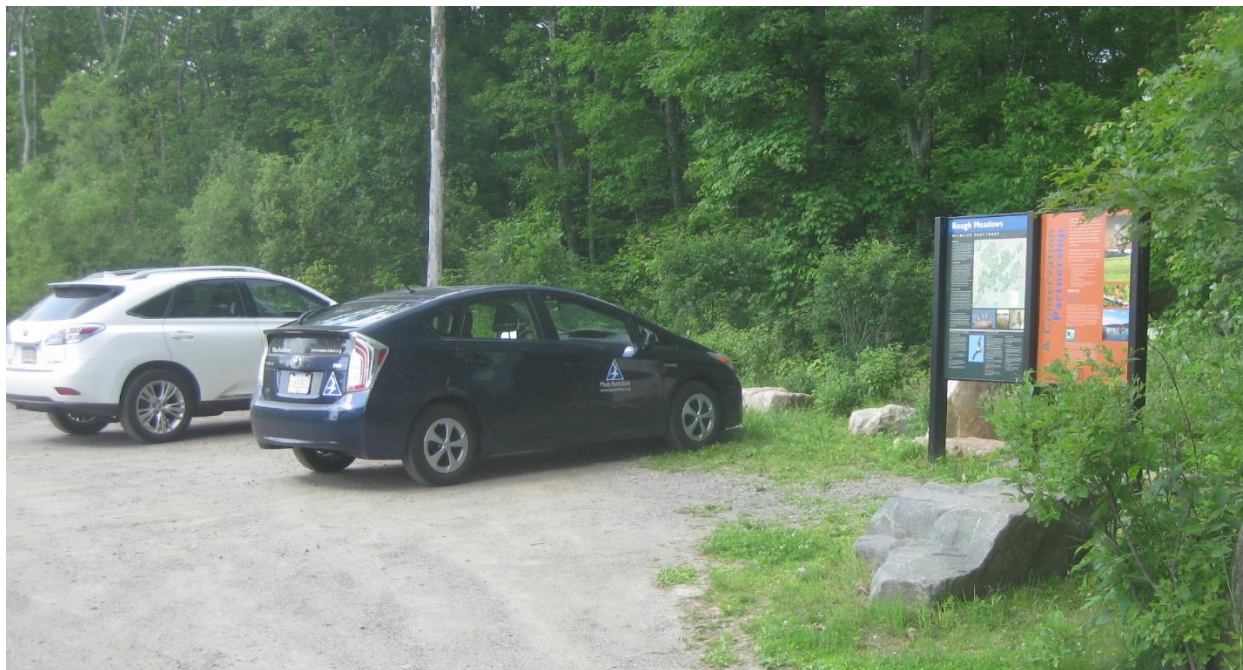
Figure 11. An example of a gravel lot with granite stone parking bumpers, Rough Meadows Wildlife Sanctuary, Rowley.

We will work with colleagues to design and install standard Mass Audubon sanctuary signage that would welcome visitors, indicate the access points and trails into the Thicket, and clearly state that parking is not permitted for beach access. A welcome kiosk will provide background information about the Thicket, information about the trail system and safety risks such as poison ivy and ticks. A similar lot at our Rough Meadows Wildlife Sanctuary in Rowley is shown in Figure 11 and typical signage is shown in Figure 12.

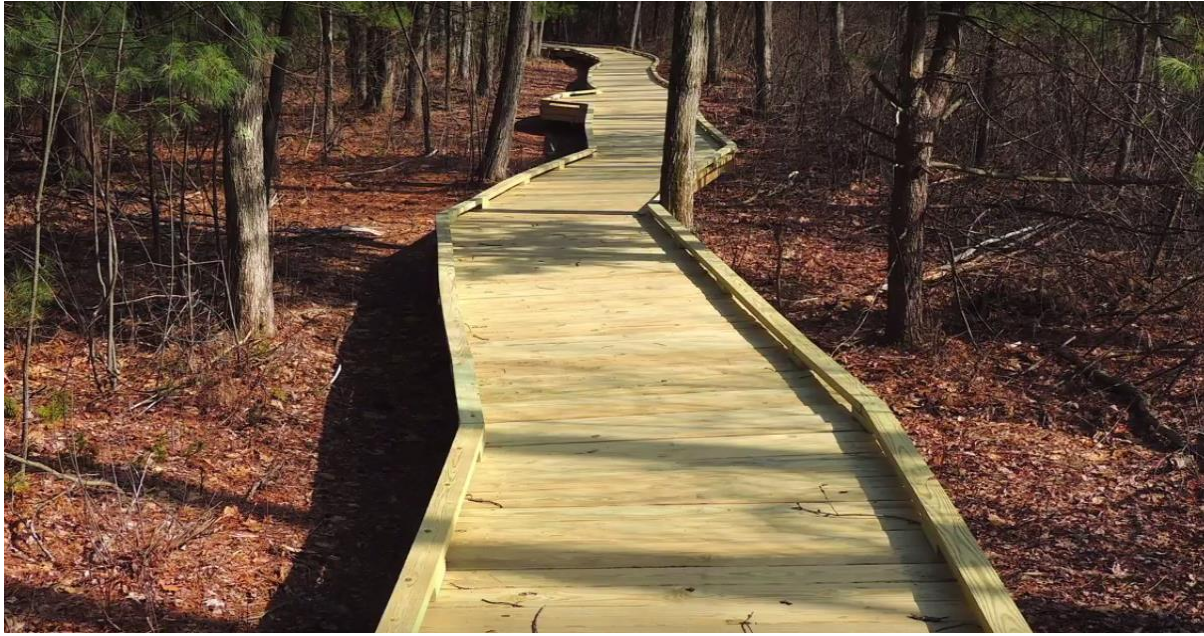
Figure 13. Raised boardwalk at Great Meadows NWR, Sudbury.

The boardwalk will use a modern design that we employed for the Red Maple Trail in partnership with U.S. Fish & Wildlife Service at the Great Meadows National Wildlife Refuge in Sudbury (Figure 13). This method makes use of metal posts augured into the soil, holding the boardwalk structure above the moist ground and involving minimal disturbance of soil. We will trim vegetation modestly, to ensure a clear walking path.

Although more costly than a dirt trail, a boardwalk will involve much less disturbance to the site and will be longer lasting and a better, more accessible surface for all users. We explored the concept of a gravel or stone dust trail which would involve clearing vegetation to about 6 feet in width, excavating four to six inches of subsoil, then installing landscaping fabric, a crushed stone base, and a fine stone dust surface. We rejected this alternative due to the extent of soil disturbance necessary, the need for heavy equipment on-site, and the fact that site hydrology would make the trail prone to flooding and necessitate costly ongoing maintenance.

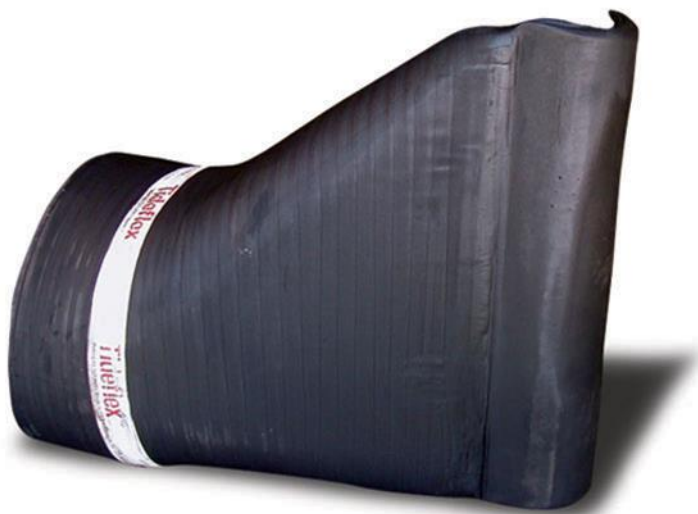
Figure 14: The TF-1 Tideflex Check Valve, an alternative to the existing flap gate.

According to a former town engineer and a long-time neighbor, the stormwater pipes are old and have not been regularly maintained in recent years, with the last power flushing of the pipes 10-15 years ago. During the site visit, trash and debris were observed covering all pipe inlets as well as within the upstream manhole, and sand and gravel were blocking the outlet of the pipe on the beach. With regular, possibly seasonal, maintenance that includes the removal of blockages from all inlets and a power flushing of the pipes, the functionality of the current stormwater system could be improved. In addition, a check valve such as the Tideflex Check Valve (Figure 14) could be added to the outfall pipe on the beach. This device would prevent accumulated sand and gravel from blocking drainage.
