## **Nature-Based Approaches to Control Erosion in high wave energy environments within Massachusetts**

### **Dynamic Cobble Beaches and Berms in Massachusetts**

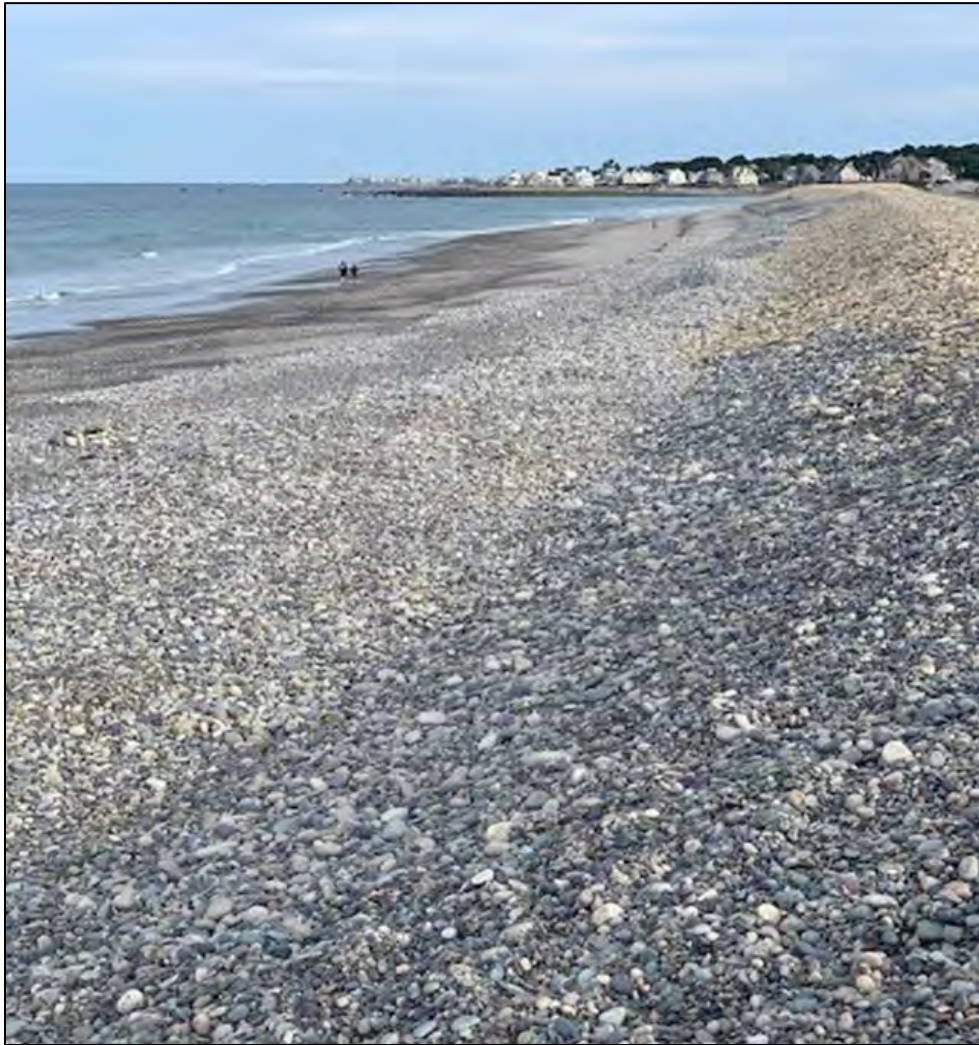
Figure 1. Mann Hill/Egypt Beach nourished by the Town of Scituate in Winter of 2020 (Photo: Sustainable Coastal Solutions).

The Mann Hill/Egypt Beach cobble berm was engineered and installed by the Town of Scituate in 1979 following the Blizzard of '78. The cobble berm was originally a naturally occurring "shingle" dunes created by erosion and littoral transport of regional glacial materials. After 1957, the Town began to monitor beach elevations along this stretch of shoreline and repair the dune system to maintain foreshore protection. The engineered cobble berm/dune was placed in 1979, and repaired by the Town in 1992, 2008, 2018, and 2020. The most notable storms to impact the dune system since the late 1950s are the Blizzard of '78, the Halloween Storm of 1991, the December Nor'easter of 1992, Winter Storm Nemo in 2013, and Winter Storm Riley in 2018. During Winter Storm Riley, earth-moving equipment was needed throughout the storm to repair various "breaches" that formed through the berm over during the storm.

The Town's repairs have consisted of restoring the cobble berm to its 1979 design height. Restoring the dune's height and supplementing the volume adds stability and restores the dunes' ability to withstand moderate nor'easter storm impacts and protect the landward infrastructure. During significant storms, the engineered berm is designed to gradually shift landward in response to storm wave energy, similar to a natural dune

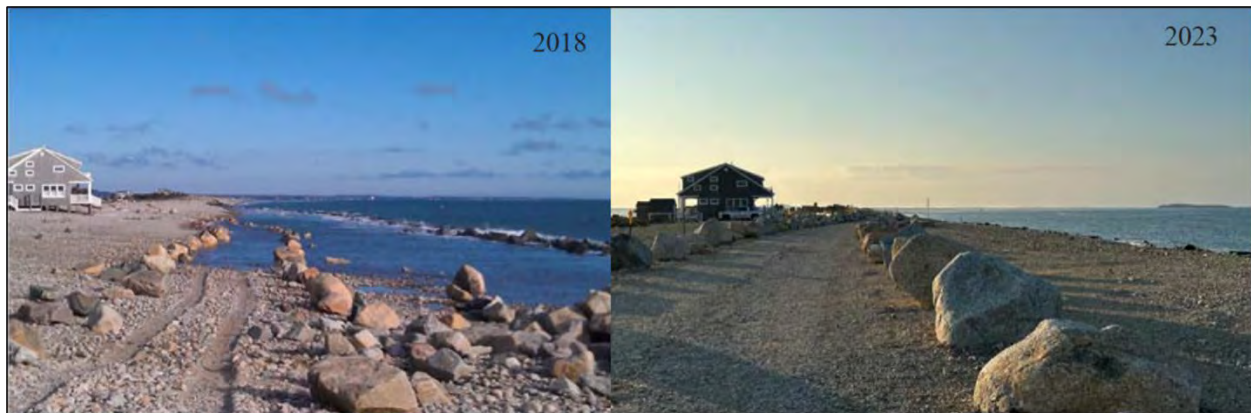
Figure 3. Plymouth Long Beach in 2018 and 2023 after the mixed sediment nourishment (Photo: Town of Plymouth).

The nourishment of the upper beach and dune system involved approximately 35,030 cubic yards of nourishment comprised of a mix of sand, gravel and cobble along a 2,000 foot long project area. The project restored the dune crest's height and bolstered the dune's volume and extent. The project's construction was completed in the winter of 2023 and has provided the Town with a stable barrier beach that has weathered numerous coastal storms. The use of mixed sediment solution provided the Town of Plymouth with a practical and effective solution to protect the Town's infrastructure while managing erosion and mitigating environmental impacts. Funding and technical assistance for this project were provided by the Massachusetts Office of Coastal Zone Management through the Coastal Resilience Grant Program.
